Manhole Inspection Summary

Manhole # S11S__022MH

Insp Date: **3/28/08 8:57 AM**

Location Address: **3220 Wilkins AV**

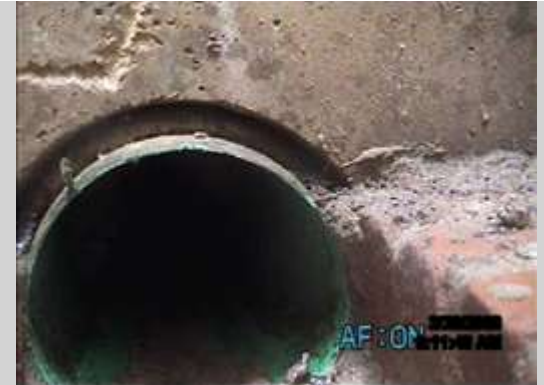
12 O'Clock Outflow

8 in. Circular Gravity Sewer
Pipe Out @ 12 O'Clock

Pipe Height: **8.4** (in.) Rod and Bar (Angled)
Pipe Material: **PVC** ☐ Pipe Lined
Invert Depth: **8.00** (ft.) Flow Characteristics: **None**
Deposits: ☒ None ☐ Mud ☐ Sludge ☐ Debris ☐ Grease
Silt Depth: **0** (in.) Deposits Extent:
Infiltration: **None** Pipe Seal Cond: **Unknown**

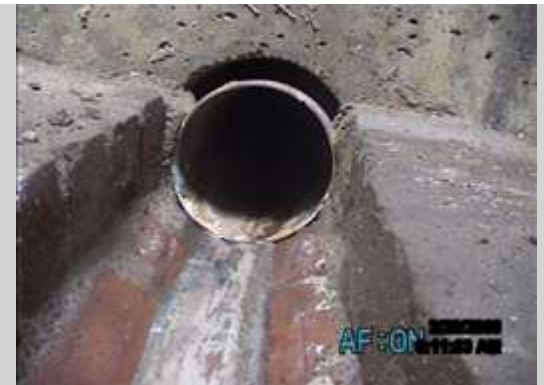
7 O'Clock Inflow

8 in. Circular Gravity Sewer
Pipe In @ 7 O'Clock

Pipe Height: **8.4** (in.) Rod and Bar (Angled)
Pipe Material: **PVC** ☐ Pipe Lined
Invert Depth: **8.00** (ft.) Flow Characteristics: **None**
Deposits: ☒ None ☐ Mud ☐ Sludge ☐ Debris ☐ Grease
Silt Depth: **0** (in.) Deposits Extent:
Infiltration: **None** Pipe Seal Cond: **Unknown**
